BRE Test Report

Wind Driven Rain Testing of Patterson & Rothwell Ltd, Classic Slate to EN 15601

Report Number: **P116822-1000 Issue: 2**

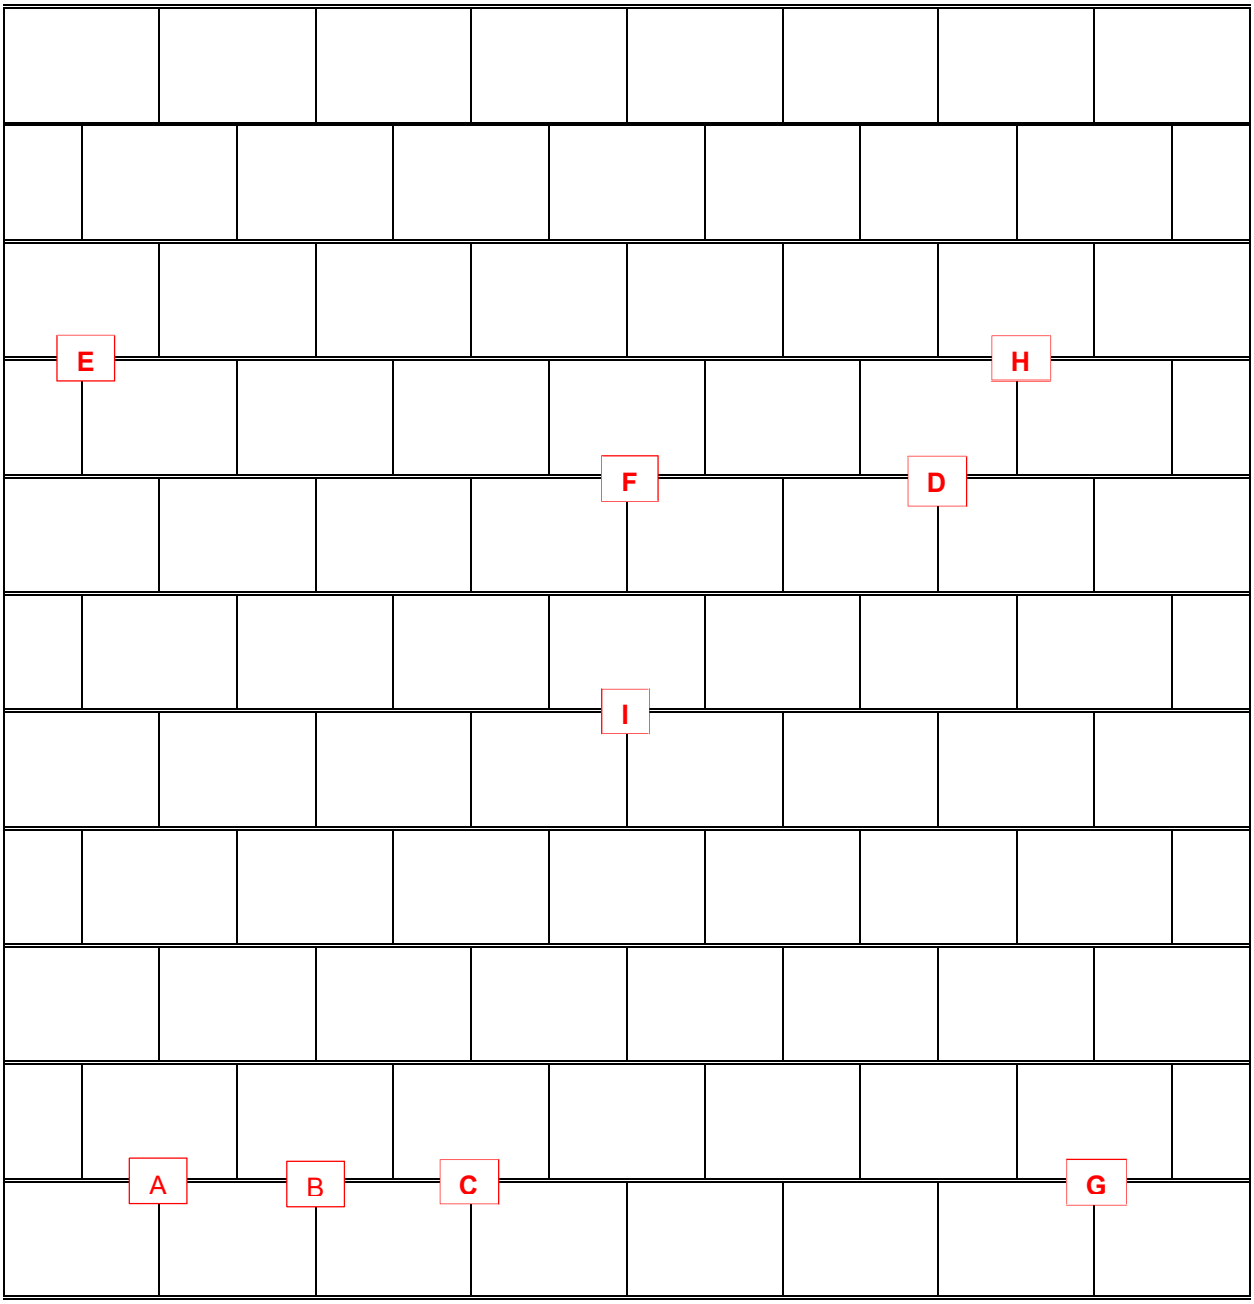
Figure 5 View from under the roof and locations of leaks @ 15

- The Patterson & Rothwell Ltd Classic Slate performed better than the chosen reference products.
- The leakage was primarily observed from the slate head laps.

Test : B High wind speed with high rainfall rate			**Pitch**: 15º
Rainfall rate:60 mm/hr			Wind speed 13 m/s
Pressure difference (Pa)	Time (min:sec) Start	End	Water collected (g)	Comments:
30	0	5	0	No leaks visible
20	5	10	0	No leaks visible
10	10	15	0	No leaks visible
0	15	20	0	No leaks visible
-10	20	25	0	No leaks visible
-20	25	30	227	A - Dripping now and again. B - Dripping now and again. C - Dripping now and again. D - Dripping approximately once every second. E - Dripping approximately 3 time every second.
-30	35	40	507	A-E - No change F - Dripping approximately 3 time every second.
-40	40	45	1055	A-C - Dripping approximately once every second. E-F – No change G - Dripping approximately once every second. H - Dripping approximately twice every second. I - Dripping approximately 3 time every second.

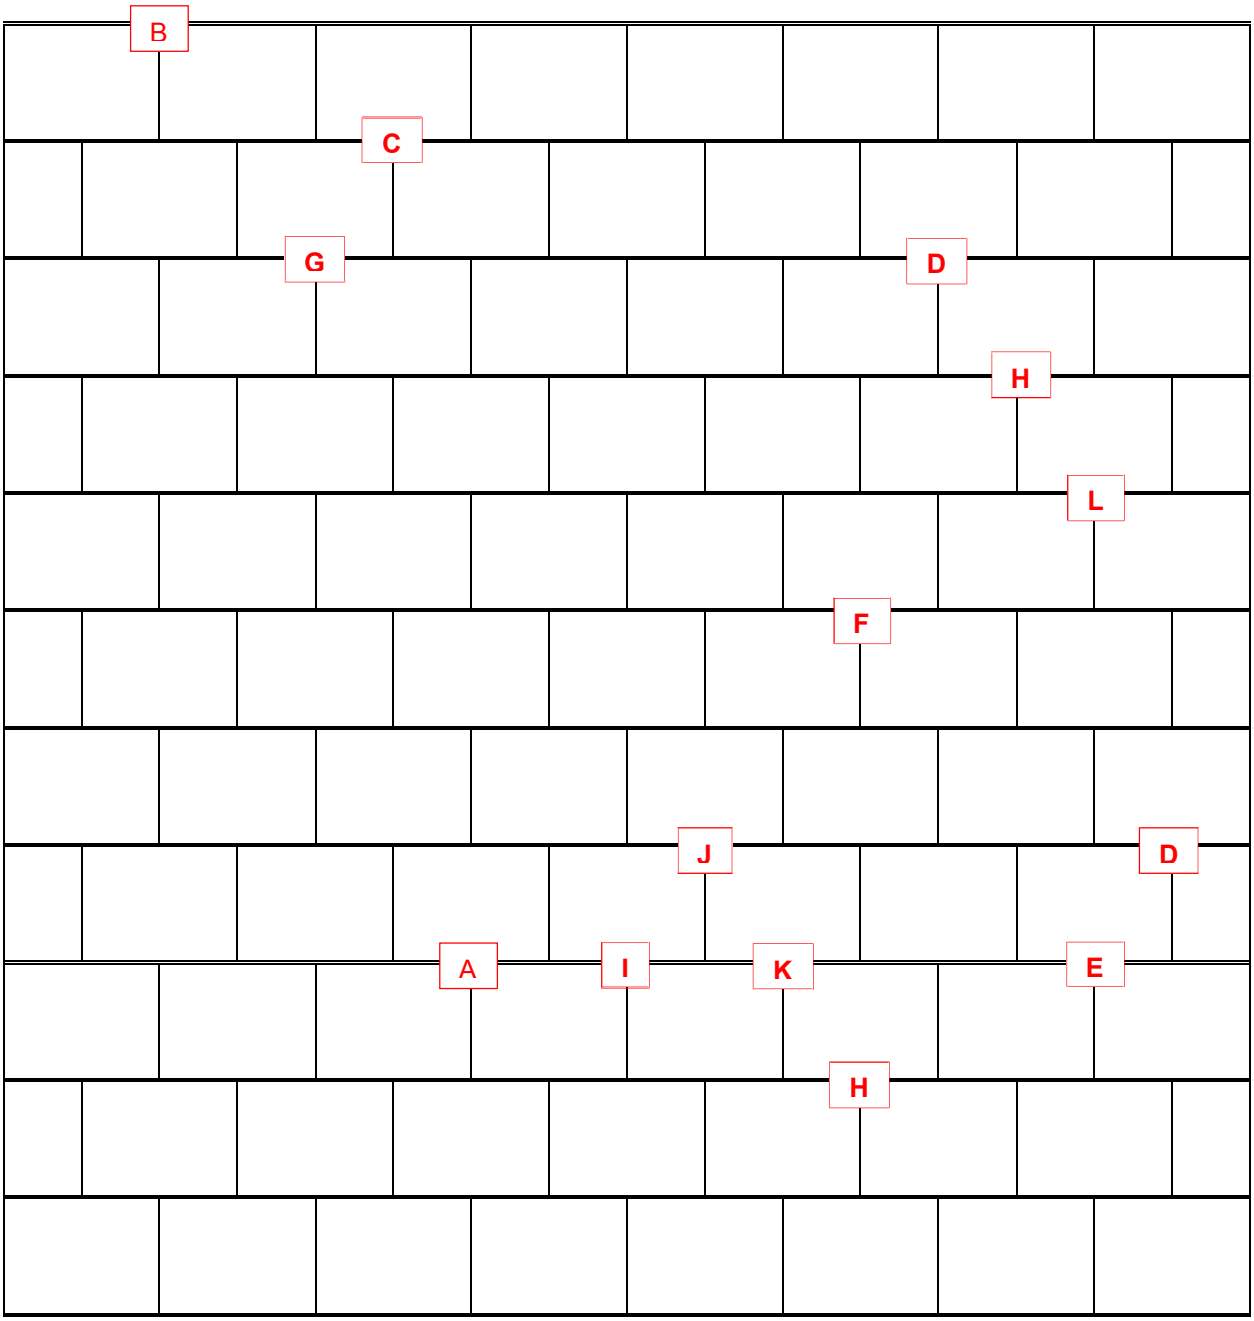
Figure 6 View from under the roof and locations of leaks @ 22.5º

Test : B High wind speed with high rainfall rate			**Pitch**: 22.5º
Rainfall rate:60 mm/hr			Wind speed 13 m/s
Pressure difference (Pa)	Time (min:sec) Start	End	Water collected (g)	Comments:
0	0	5	0	No leaks visible
-10	5	10	0	No leaks visible
-20	10	15	11	A – Dripping now and again.
-30	15	20	45	A – Dripping now and again. B – Dripping now and again. C – Dripping now and again.
-40	20	25	107	A - C – Dripping now and again. D – Dripping approximately once every 3 seconds.
-50	25	30	314	A-D – No change E – Dripping approximately 3 time every second. F – Dripping approximately twice every second. G – Dripping approximately 3 time every second.
-60	35	40	573	A-G – No change H – Dripping approximately twice every second. I – Dripping approximately once every second. J – Dripping approximately once every second.
-70	40	45	824	B-H – No change A – Water streaming approximately every 2 seconds. I – Water streaming approximately every 2 seconds. L – Dripping approximately once every second. F – Dripping approximately once every second. M – Water streaming approximately every 2 seconds.

-80	45	50	1056	Most areas across the roof now leaking
